HOME INSPECTION REPORT

59 Mullock Ave
Toronto

Inspection Date: March 14 2024

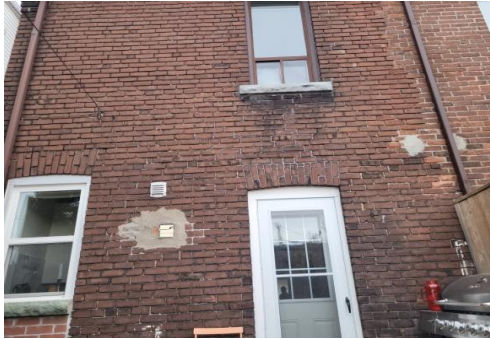
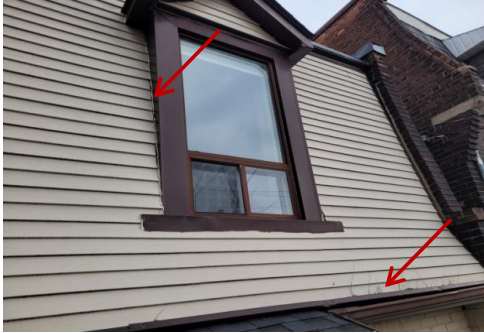
REFERENCE LINK		http://redbrickinspections.ca/docs/3_Exterior_Reference_Guide.pdf	
59 Mulock Ave		<div>EXTERIOR</div> <div>March 14 2024</div>	
Description			
Gutters & Downspouts: Aluminum:	Downspout(s) Discharge: Various Above Grade	Lot Topography: Flat	Walls & Wall Structures: Brick Vinyl Siding
Limitations			
Exterior Inspection from Ground Level Restricted Access Under Porch(es)			
Observations/Recommendations			
<p> **Gutters/Downspouts: overall in good repair extend 6-ft away from house </p> <p> WALL SURFACES: Soffit & Facia: requires general repairs and maintenance Brick: overall in good repair, repair mortar as required Vinyl Siding: overall in good repair, front dormer requires caulking/maintenance </p> <p> DOORS/WINDOWS: overall in good repair, repair mortar as required </p> <div>

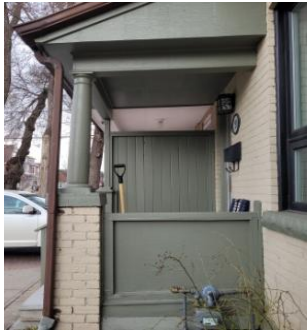
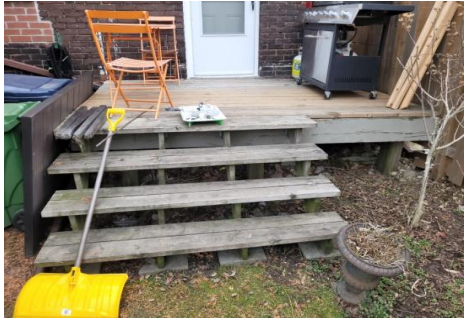
</div> <p> PORCH columns skewed though not unusual - monitor and budget to repair **Walk(s): repair along foundation wall, seal gaps along foundation wall DECK overall in good repair, provide hand railings for safety </p> <div>

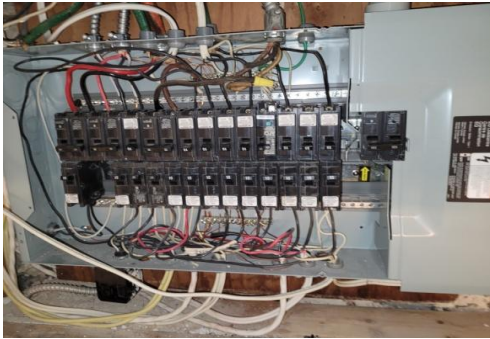
</div> <p>BRANCH WIRING: random sampling determined majority wiring has been upgraded throughout</p> <p>Knob & Tube: observed in basement above panel - not determined if in use, further evaluation and recommend removing/replacing</p> <p>BRANCH WIRING: basement: loose wires, ungrounded/reverse polarity outlets</p> <p>overall basement requires general repairs</p>

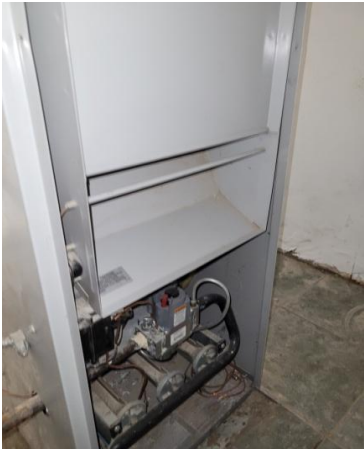
REFERENCE LINK		http://redbrickinspections.ca/docs/6_Heating_Reference_Guide.pdf					
59 Mulock Ave		HEATING				March 14 2024	
Description							
Description:	Efficiency:	Rated Input:	Approx. Age:	Life Expectancy:	Fuel Type:	Shut Off at:	
Forced Air Furnace:	Low	90 x1000BTU/hr	36 yrs.	20+ yrs.	Gas	Meter-Exterior	
Exhaust Vent Arrangement:		Metal Through Masonry Chimney					
Limitations					Furnace Performance		
Heat Loss Calculations Not Done					Supply Temp F: 120		
Heat Exchanger- Limited Access					Return Temp F: 70		
Observations/Recommendations							
<p>FORCED AIR FURNACE: old, rusting, continue servicing until replacement becomes necessary annual CO test mandatory for this type of unit recommend upgrading to high efficiency unit</p> <p>Humidifier: old, replace</p> <div style="display: flex; justify-content: space-around; align-items: flex-start;">
