# HOME INSPECTION REPORT

260 Windermere Ave

Prepared for: The Motria Group

Inspection Date: March 6 2025

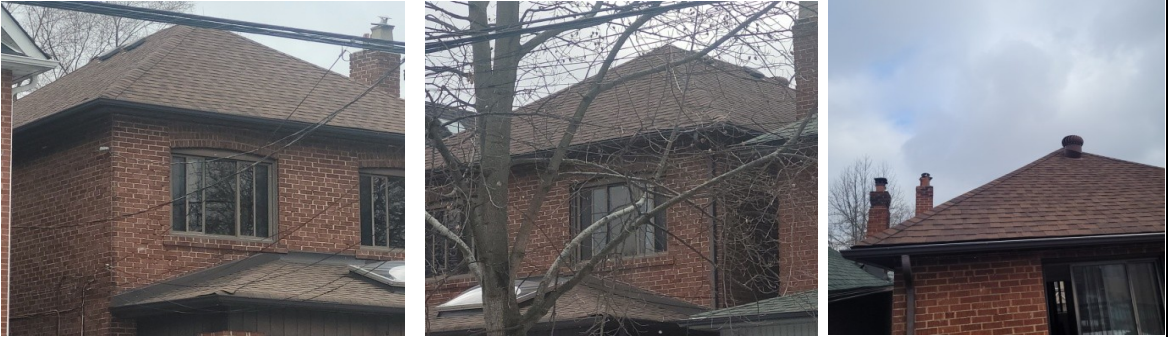
REFERENCE LINK		<a href="http://redbrickinspections.ca/docs/2_Roofing_Reference_Guide.pdf">http://redbrickinspections.ca/docs/2_Roofing_Reference_Guide.pdf</a>	
260 Windermere Ave		<b>ROOFING/Chimneys</b>	
		March 6 2025	
Description			
Roofing Material:	Location:	Leakage Probability:	Chimney(s) Type:
Asphalt Shingles:	Slope:	Low	Brick:
Modified Bitumen:	Flat:	Low deck	Location:
Modified Bitumen:	Garage:	Low	North
Limitations			
Roof Inspected By:	Access Limited By:	Chimney Access Limited By:	
From Grade	Height	Height	
From Edge	Snow		
Observations/Recommendations			
Tree Branches: <a href="#">retain arbourist for annual monitoring/trimming</a>			
Sloped Surface: <a href="#">overall surface in good repair</a>

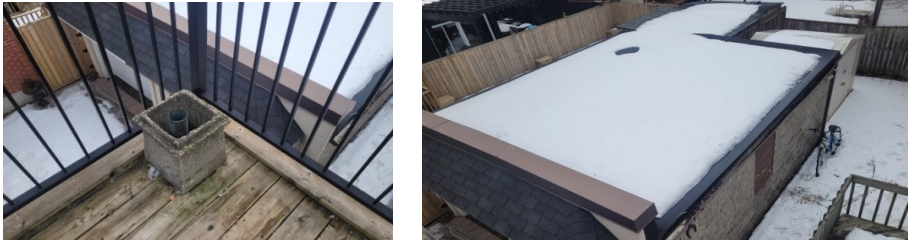
Deck: <a href="#">not visible due to deck: extend stack above upper roof line</a>			
Porch(s): <a href="#">overall surface in good repair</a>			
Garage: <a href="#">not visible due to snow</a>

Chimney(s): <a href="#">requires clay liner/brick repairs</a>

Note: Recommend Annual Maintenance Contract for Roof Surface, Flashing Details and Chimney(s)

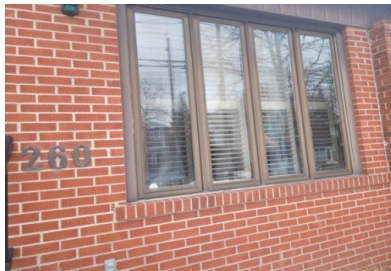
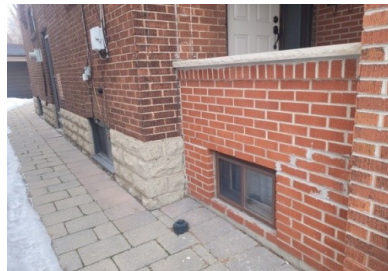
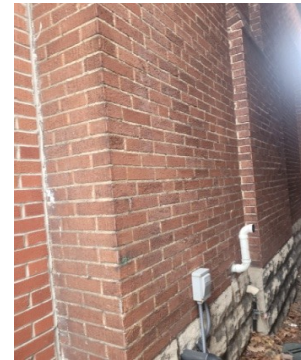
**DOORS/WINDOWS:** overall in good repair, general calking repairs

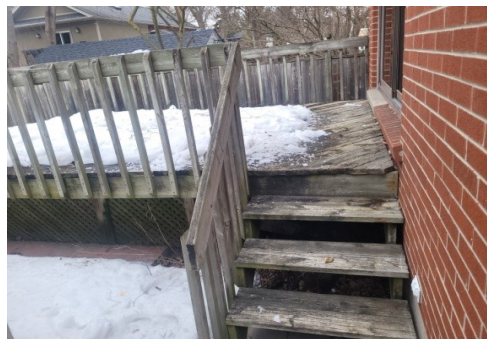
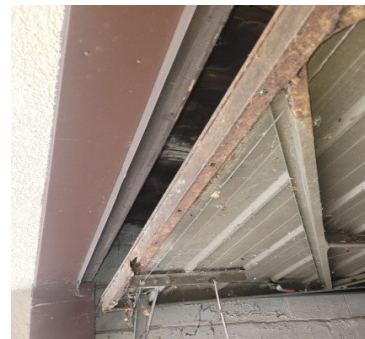
**DECK(s):** older, service/repair as required

**DETACHED GARAGE:** overall well built, maintain as required  
older door

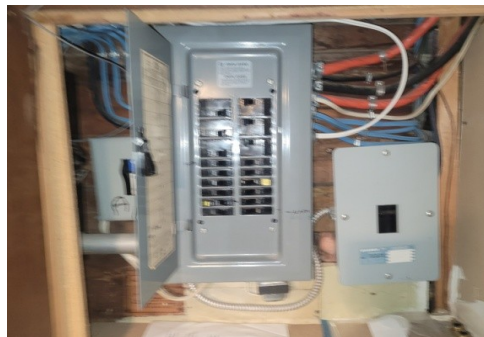
SERVICE PANEL: panel obstructed by cabinet - cover not removed, further evaluation anticipate upgrading to larger panel

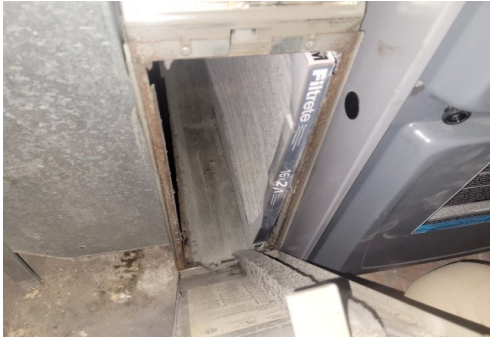
REFERENCE LINK		<a href="http://redbrickinspections.ca/docs/6_Heating_Reference_Guide.pdf">http://redbrickinspections.ca/docs/6_Heating_Reference_Guide.pdf</a>			
260 Windermere Ave		<b>HEATING</b>		March 6 2025	
<b>Description</b>					
Description:	Efficiency:	Rated Input:	Approx. Age:	Life Expectancy:	Fuel Type: Shut Off at:
Forced Air Furnace:	High	60 x1000BTU/hr	3 yrs.	20 yrs.	Gas Meter-Exterior
Exhaust Vent Arrangement: Plastic Through-Wall Vent					
<b>Limitations</b>				<b>Furnace Performance</b>	
Heat Loss Calculations Not Done				Supply Temp F: 120	
Heat Exchanger- Inaccessible				Return Temp F: 70	
<b>Observations/Recommendations</b>					
<p>FORCED AIR FURNACE: <a href="#">service annually</a></p> <p>Electronic Filter: <a href="#">not in use, disconnect power to unit, disposable filter in use- replace 1-per-6 to 12 months</a></p>

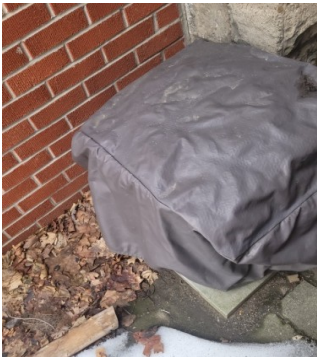
REFERENCE LINK		<a href="http://redbrickinspections.ca/docs/7_AC_Heat_Pump_Reference_Guide.pdf">http://redbrickinspections.ca/docs/7_AC_Heat_Pump_Reference_Guide.pdf</a>	
260 Windermere Ave		<b>COOLING/Heat Pumps</b>	
		March 6 2025	
<b>Description</b>			
Description:	Cooling Capacity:	Approx. Age:	Typical Life Expectancy:
Air Conditioner (air-cooled):	24 x1,000 BTU/hr	20 yrs. old	15 to 20 yrs.
<b>Limitations</b>		<b>Cooling Performance</b>	
Cannot Test With Low Outdoor Temp		Supply Temp F:	
Outdoor Coil Covered		Return Temp F:	
<b>Observations/Recommendations</b>			
<p>AIR CONDITIONER: not tested: should be serviced before using old unit, continue servicing until replacement becomes necessary</p>

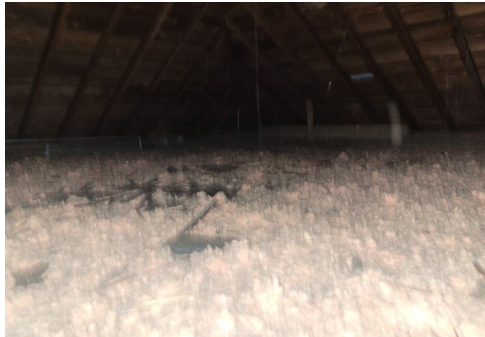
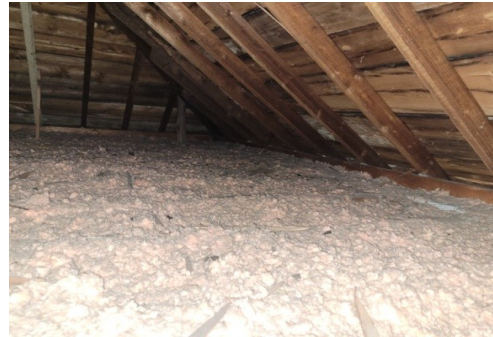
ROOF SPACE: recommend upgrading insulation to improve comfort and efficiency
