# HOME INSPECTION REPORT

260 Windermere Ave

Prepared for: The Motria Group

Inspection Date: March 6 2025

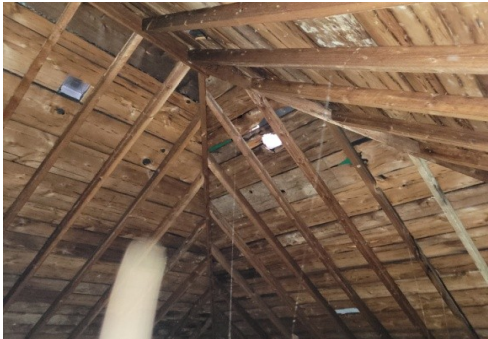
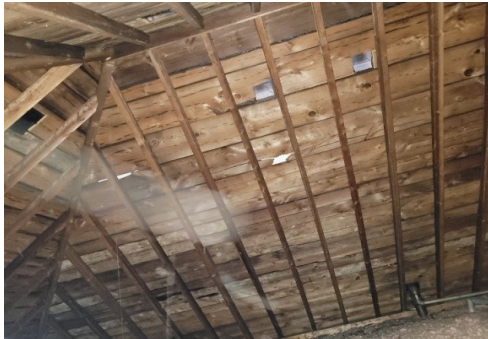
REFERENCE LINK		<a href="http://redbrickinspections.ca/docs/4_Structure_Reference_Guide.pdf">http://redbrickinspections.ca/docs/4_Structure_Reference_Guide.pdf</a>		
260 Windermere Ave		<b>STRUCTURE</b>		March 6 2025
<b>Description</b>				
Configuration: Basement:	Foundations: Masonry Block	Floor : Wood Joists	Walls : Masonry (Double-Brick)	Roof/Ceiling Framing: Wood Rafters/Joists
<b>Limitations</b>				
Restricted Access to: Wall Space	Foundation Wall Not Visible: <u>90</u> % Roof Space Inspected From Access Hatch			
<b>Observations/Recommendations</b>				
<p>overall well built house</p> <p>ROOF: overall in good repair</p> <div style="display: flex; justify-content: space-around;">
